**PHASE II ENVIRONMENTAL SITE ASSESSMENT
AND CLEANUP ALTERNATIVES EVALUATION REPORT
FOR
1080 SHERIDAN BOULEVARD, DENVER, CO**

Date Prepared	April 2015
TDD No.	0003/1503-01
Document Control No.	W0213.1A.00433
Contract No.	EP-S8-13-01
U.S. EPA Work Assignment Manager	William Rothenmeyer/Blake Huff

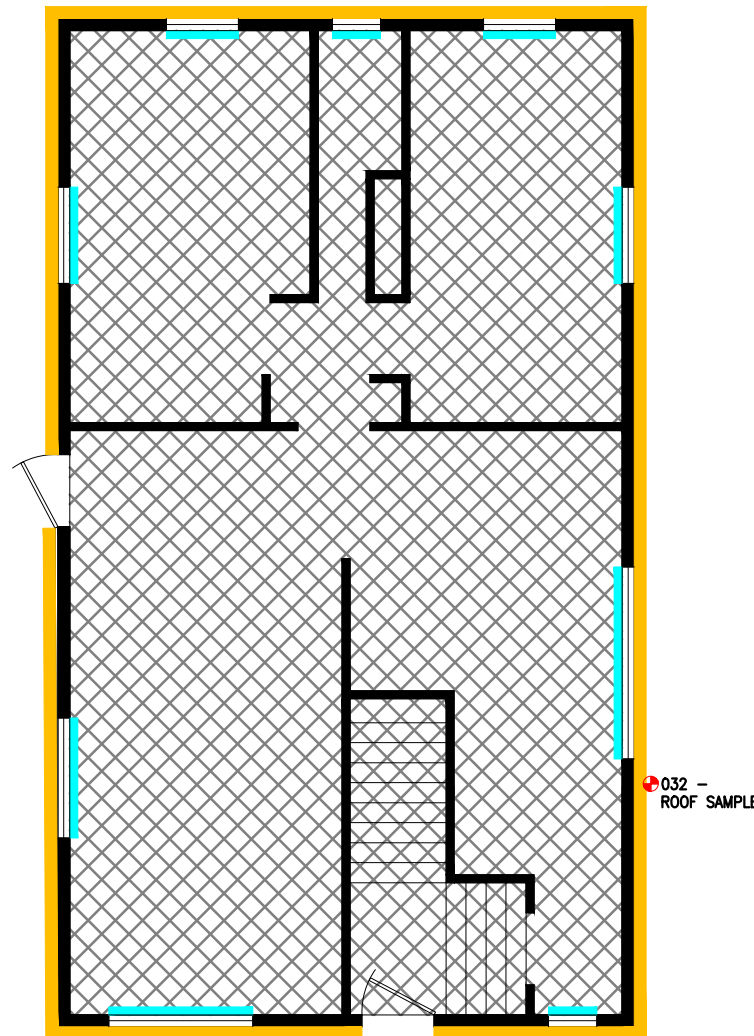
Figure
3

Ceiling Drywall/Texture	=	1,000	sq. ft.
Window Glazing	=	1	sq. ft.
Roofing Material	=	1,150	sq. ft.
ACM Totals	=	2,151	sq. ft.

- The drywall used to finish the ceilings in the upper and lower units of the residence is considered ACM. However, it is contained behind surfacing materials and, unless disturbed, is considered non-friable. START recommends that prior to any renovations, work penetrating the ceilings, or demolition that a proper plan for mitigation and/or disposal of ACM should be conducted; and that any work conducted should be performed by a company certified to handle ACM materials. Additionally, the house roofing material should be removed and disposed of properly as ACM prior to renovation of the roof or demolition.

- LBP Recommendations:
 - It is recommended that any exterior renovation or remediation activities be conducted by EPA Lead-Safe Certified contractors in accordance with Lead Safe Renovation, Repair and Painting (RRP) practices. Remediation may include proper encapsulation or removal of painted services.

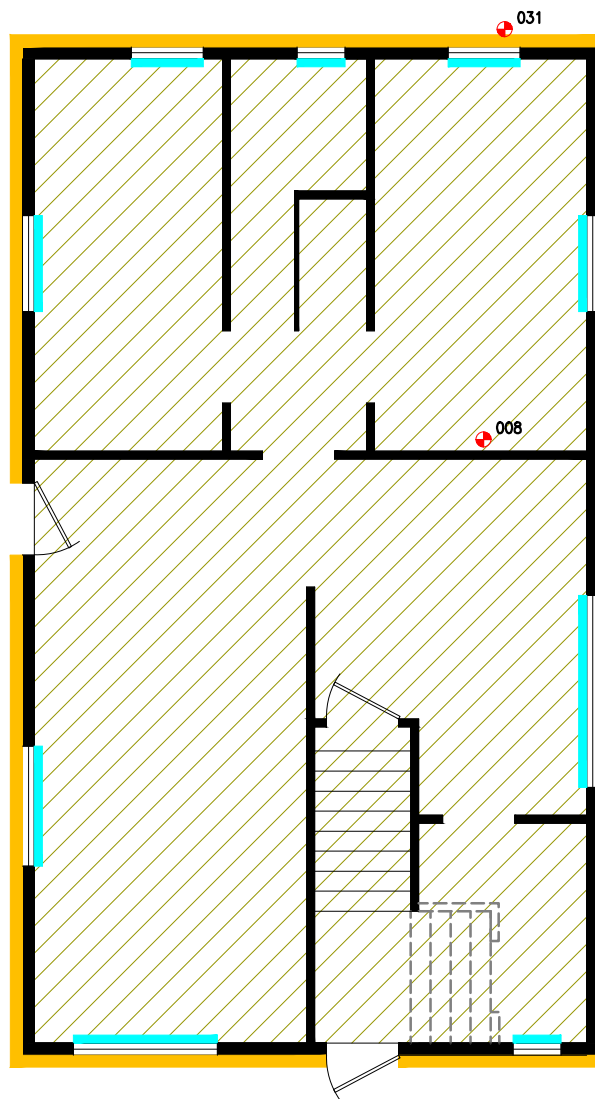
1. ALL WINDOW GLAZING IS CONSIDERED ACM, SEE FIGURE 4 (SAMPLE 031) FOR LOCATION OF GLAZING SAMPLE COLLECTED.
2. NO ACM DRYWALL, INSULATION, OR ADDITIONAL MISCELLANEOUS MATERIALS WERE IDENTIFIED DURING THE GARAGE ASBESTOS SURVEY.

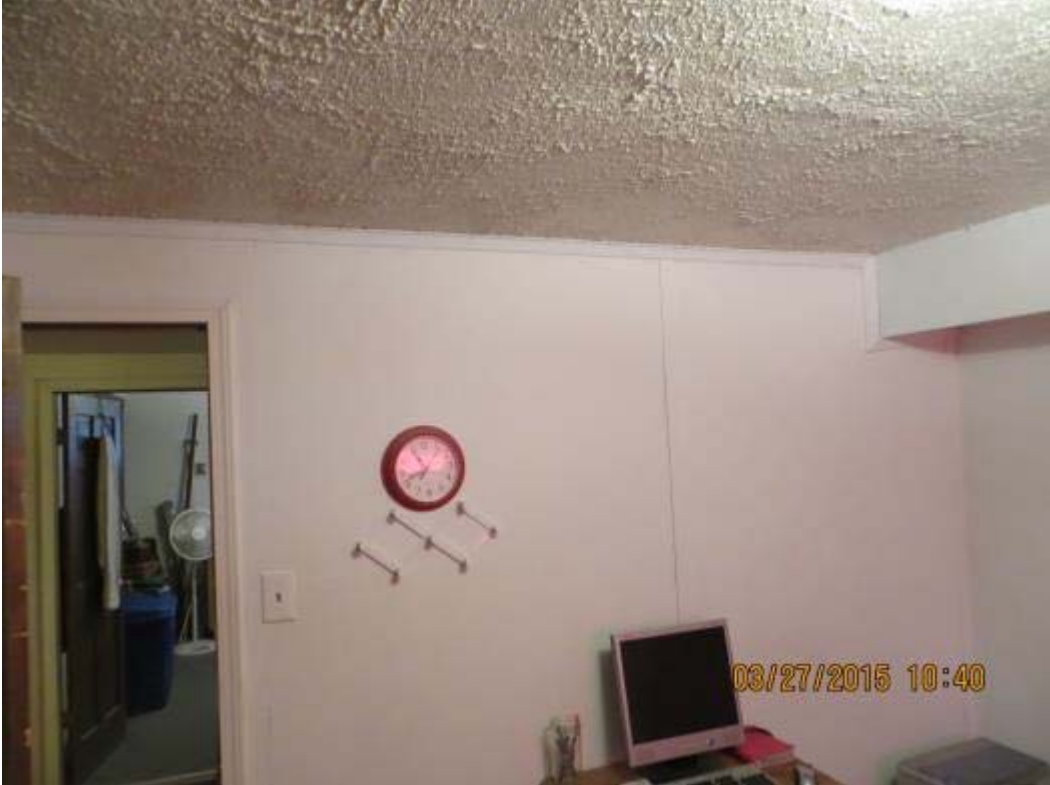
Photo No. 5	Date: 03/27/2015

Direction Photo Taken: West		
Description: Ceiling texture and wallboard in eastern bedroom of the basement unit.

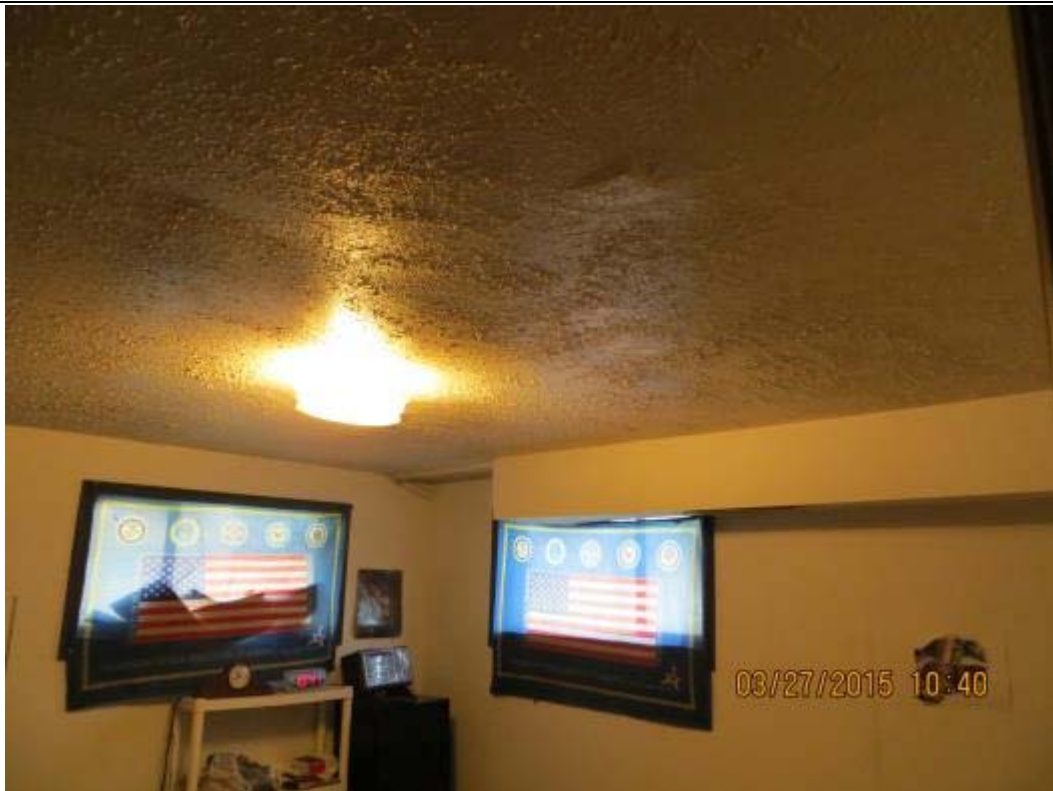
Photo No. 7	Date: 03/27/2015

Direction Photo Taken: Northwest		
Description: Ceiling texture in the western bedroom of the basement unit.

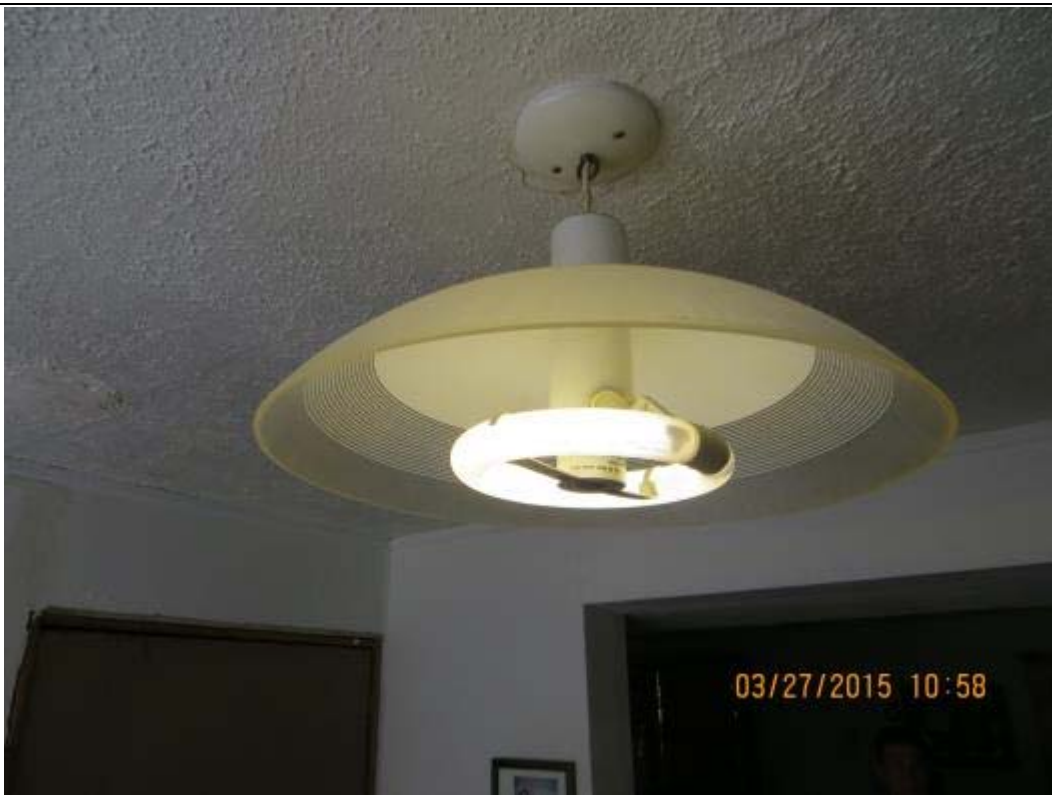
Photo No. 9	Date: 03/27/2015

Due to the lack of “No PCBs” sticker observed on the two light ballasts, PCBs are considered a potential COC in relation to the Site.

Direction Photo Taken: Up		
Description: Light in basement unit's kitchen with no label stating "No-PCBs".		
Photo No. 10	Date: 03/27/2015

- If the single family house or garage is to be demolished, a toxicity characteristic leaching procedure (TCLP) sample may be necessary prior to disposal of building materials at the selected landfill.
- Remove and properly dispose of potential PCB containing ballasts.

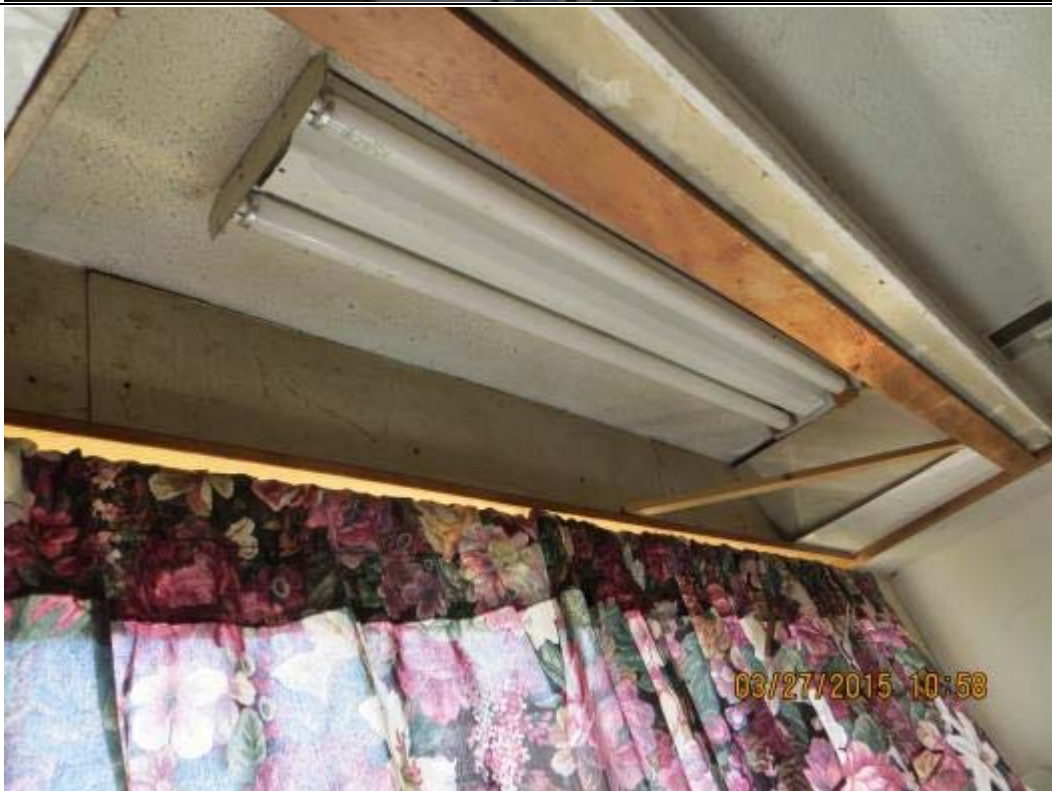
Direction Photo Taken: Up		
Description: Light in basement unit's kitchen with no label stating "No-PCBs"

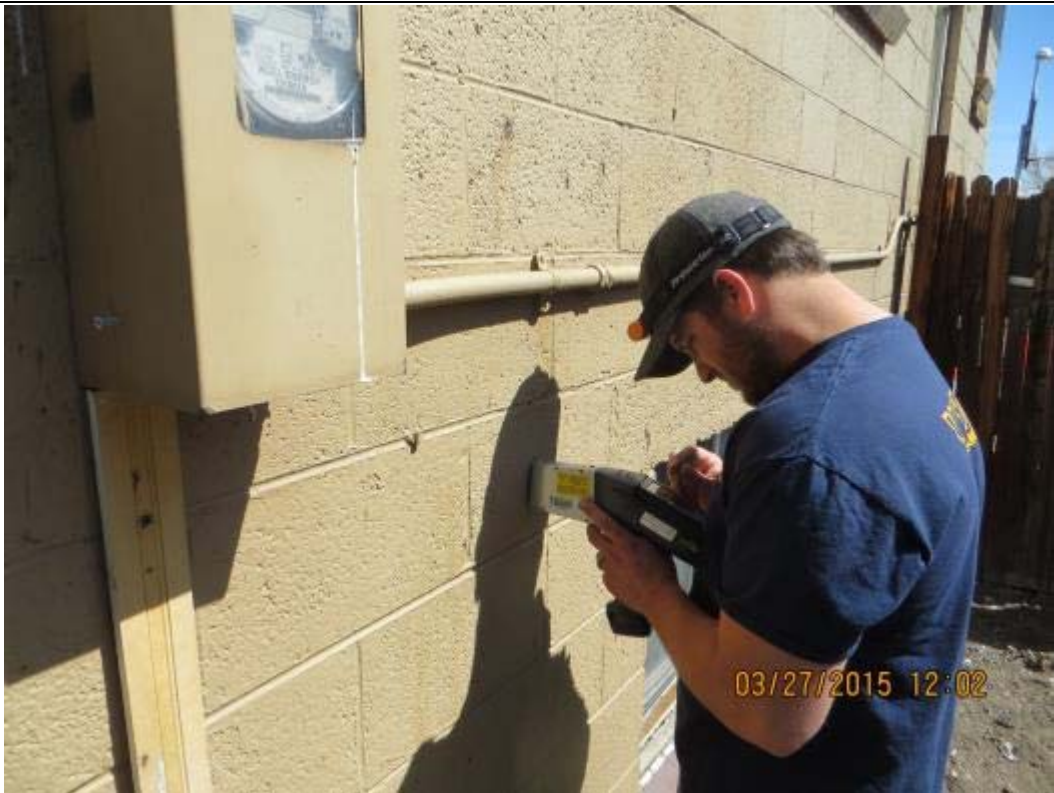
Photo No. 25	Date: 03/27/2015

Direction Photo Taken: East		
Description: House exterior, south side, tested positive for lead based paint		
Photo No. 26	Date: 03/27/2015

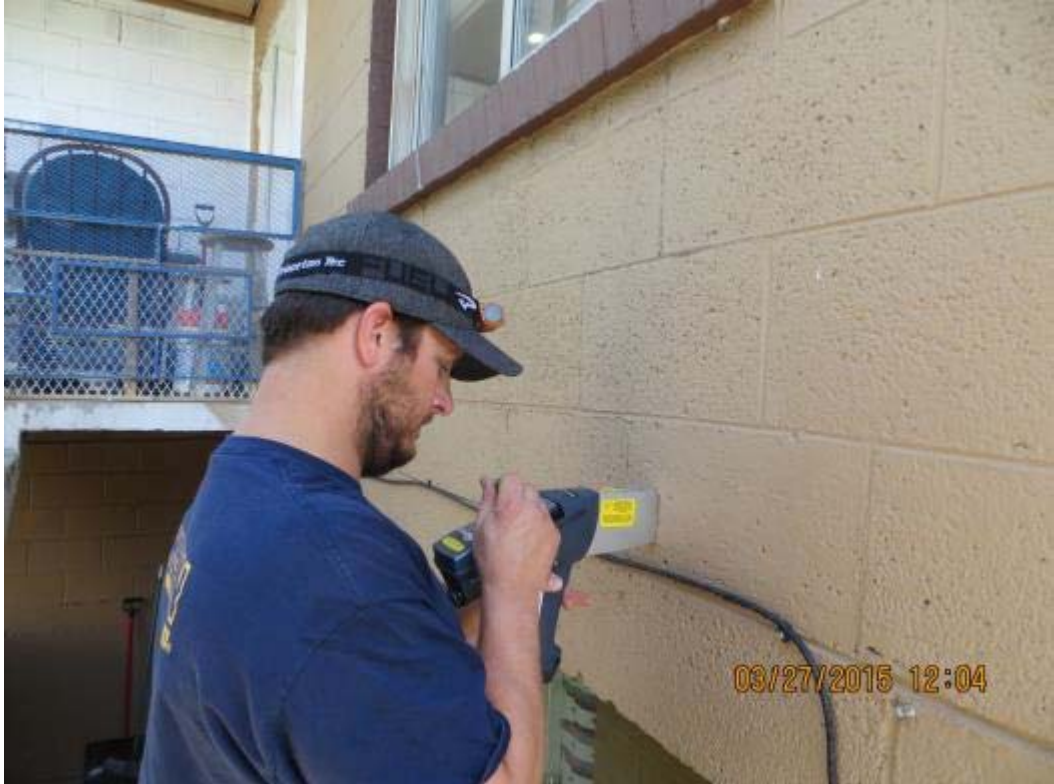
Direction Photo Taken: North		
Description: House exterior, west side, tested positive for lead based paint

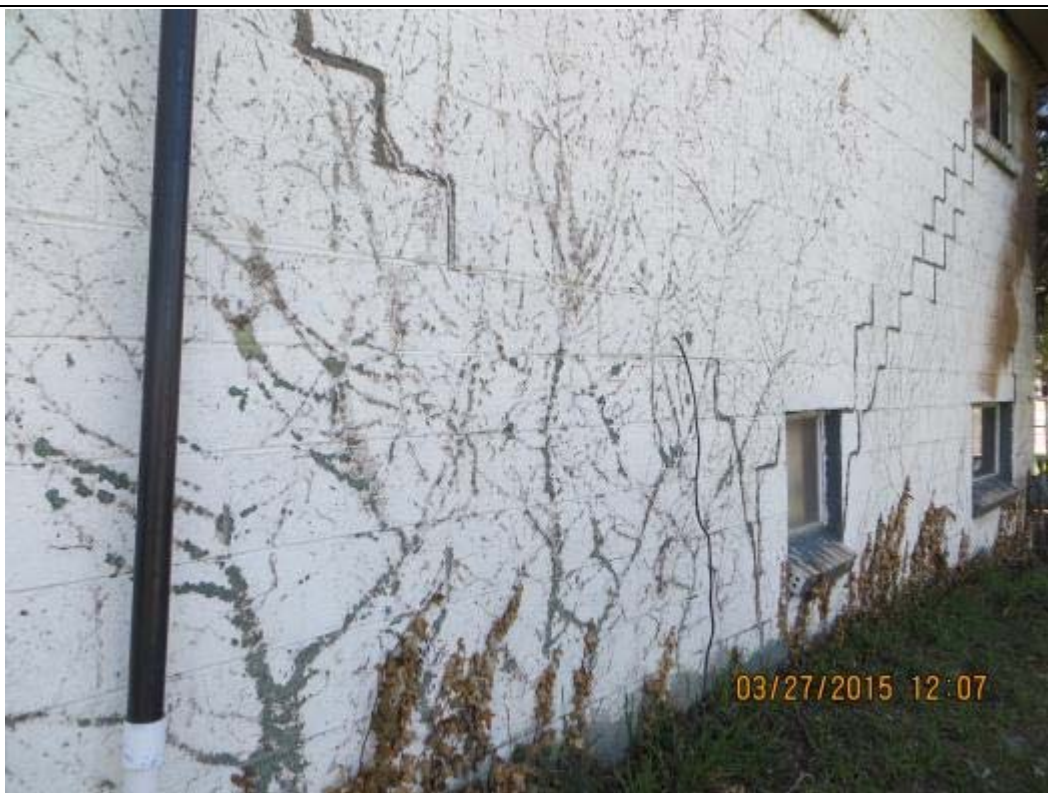
House exterior, north side, tested positive for lead based paint

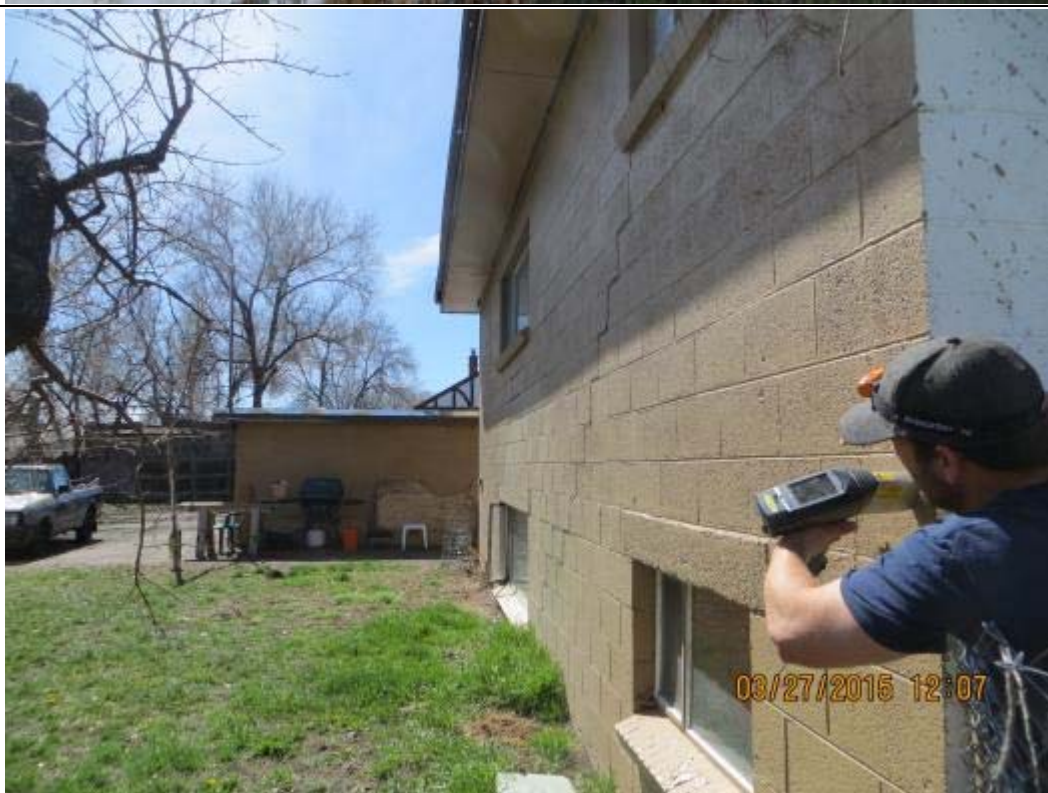
House exterior, east side, tested positive for lead based paint

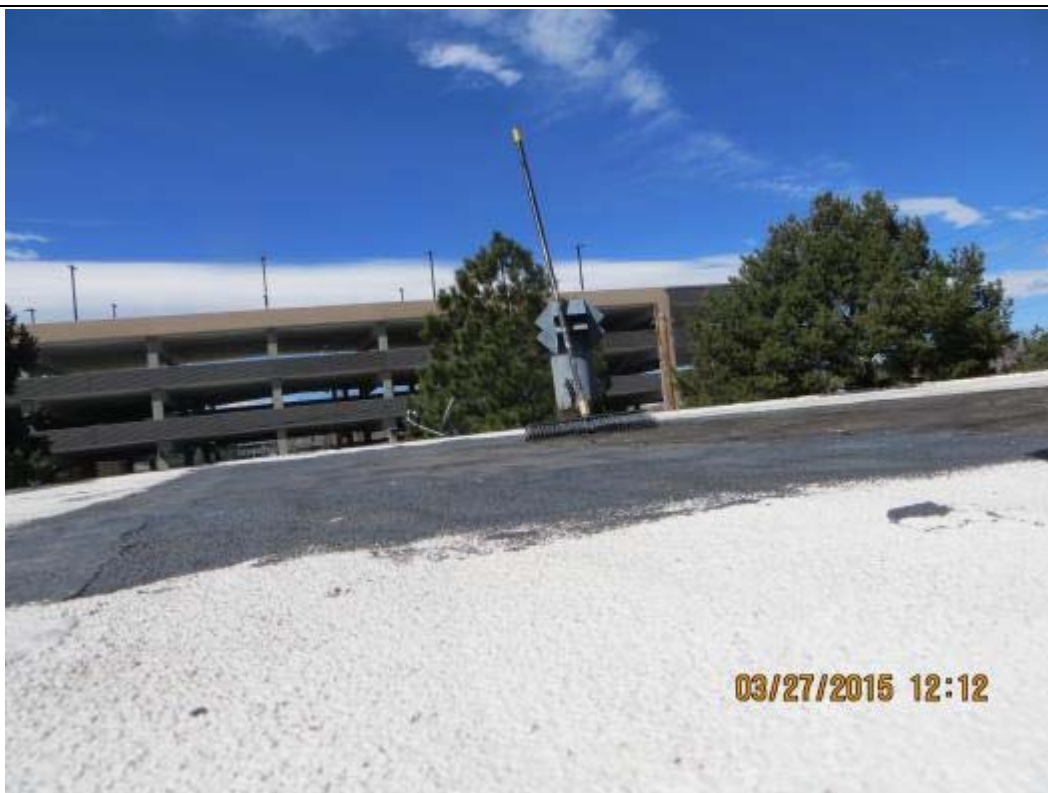
House roofing materials

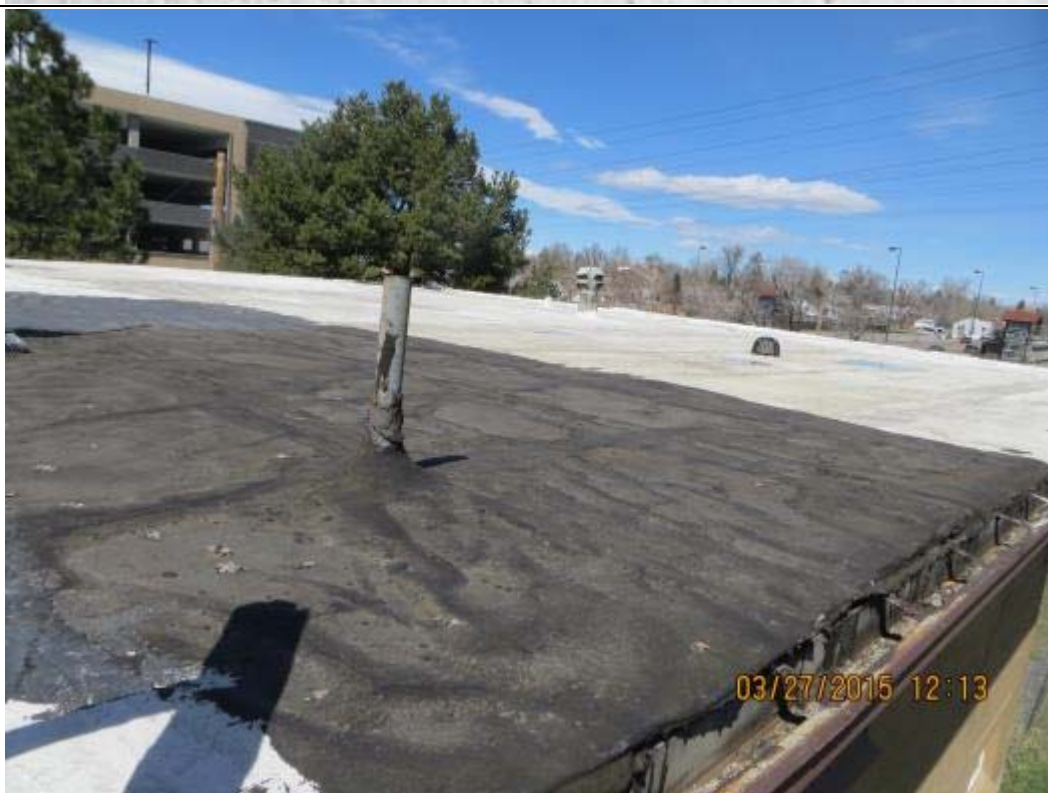
House roofing materials

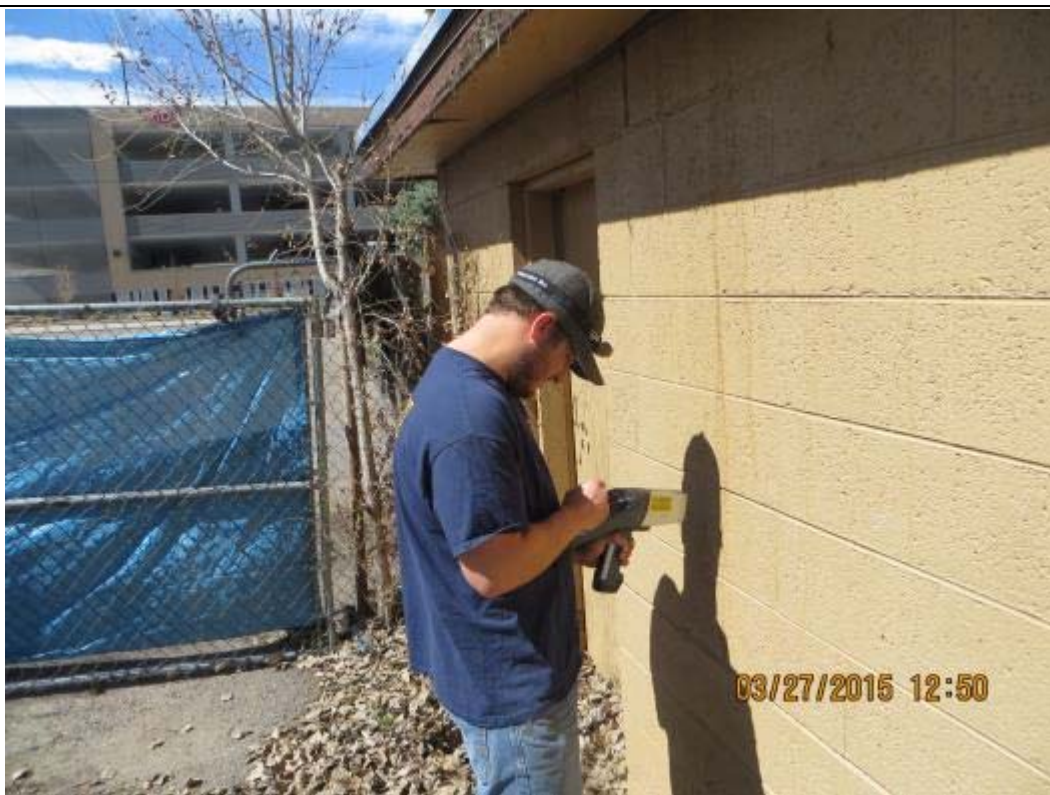
Garage exterior, south side, tested positive for lead based paint
